**Subject: Annual Inspection Report
Grove Hill Municipal Airport**

JULY 6, 2011

ANNUAL INSPECTION REPORT

GROVE HILL MUNICIPAL AIRPORT

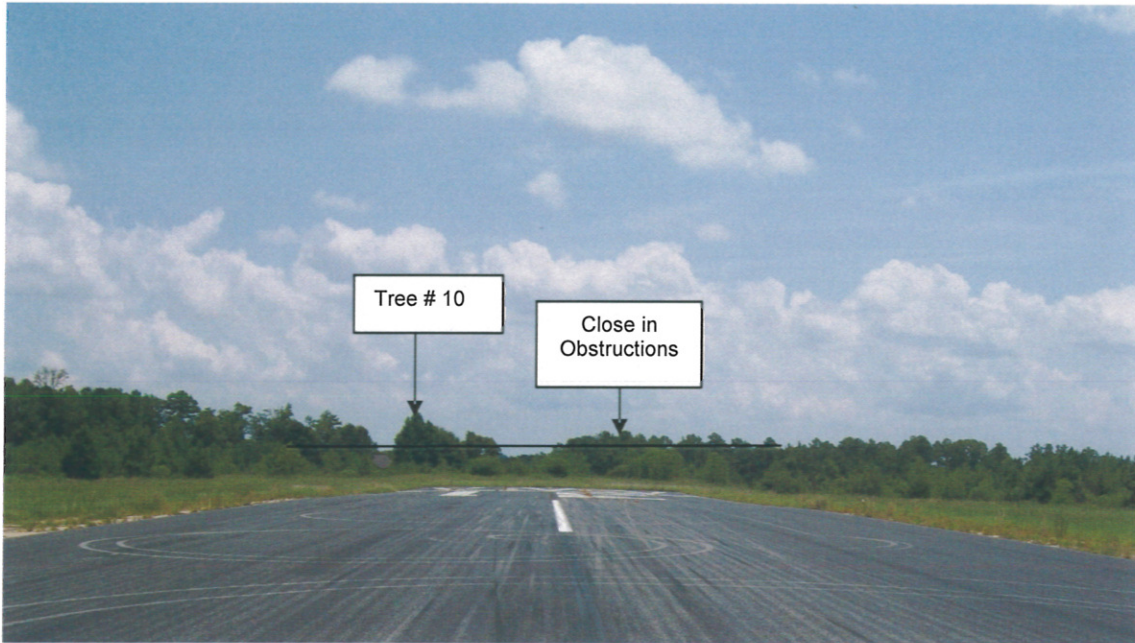
Photo # 1 – Runway 31 Obstructions

- Runway 31 – Brush identified as Brush # 1 - # 8 and Tree # 10 obstruct the ALDOT 20:1 approach/departure path from the displaced threshold (See Photo # 1, and Appendix 2).
- Runway 13 – Trees identified as Tree # 12 and Tree # 13 obstruct the ALDOT 20:1 approach/departure path (See Photo # 2 and Appendix 3).

- Remove all obstructions.

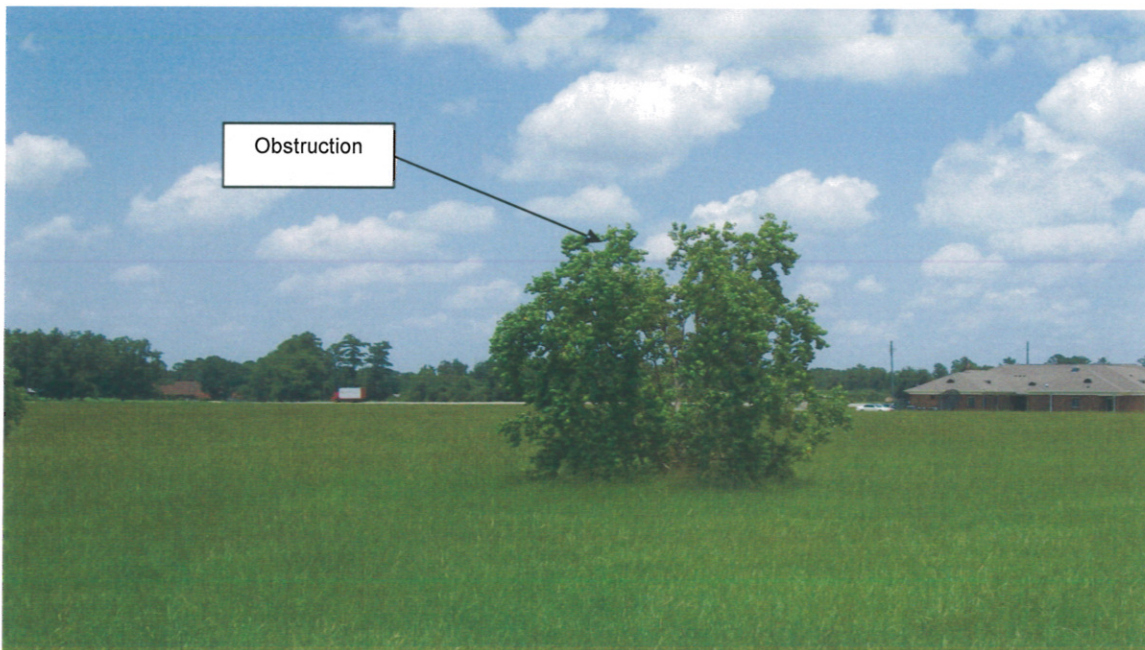
Photo # 3 – Primary Surface Obstruction

- The primary surface on the north side of the runway is obstructed by a small tree growing within 125' of the runway centerline. (See Photo # 3).

- Remove obstruction.

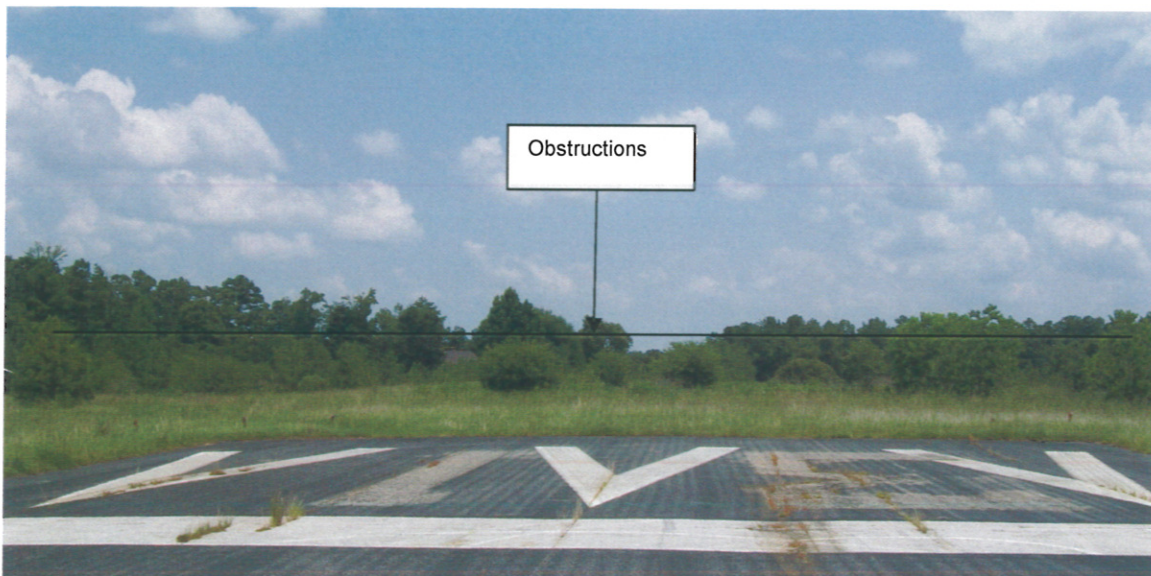
Photo # 4 – Safety Area Obstructions

- Runway 31's safety area is obstructed by brush described in Section 1 (See Photo # 4 and Appendix 2).

- Remove Obstructions.

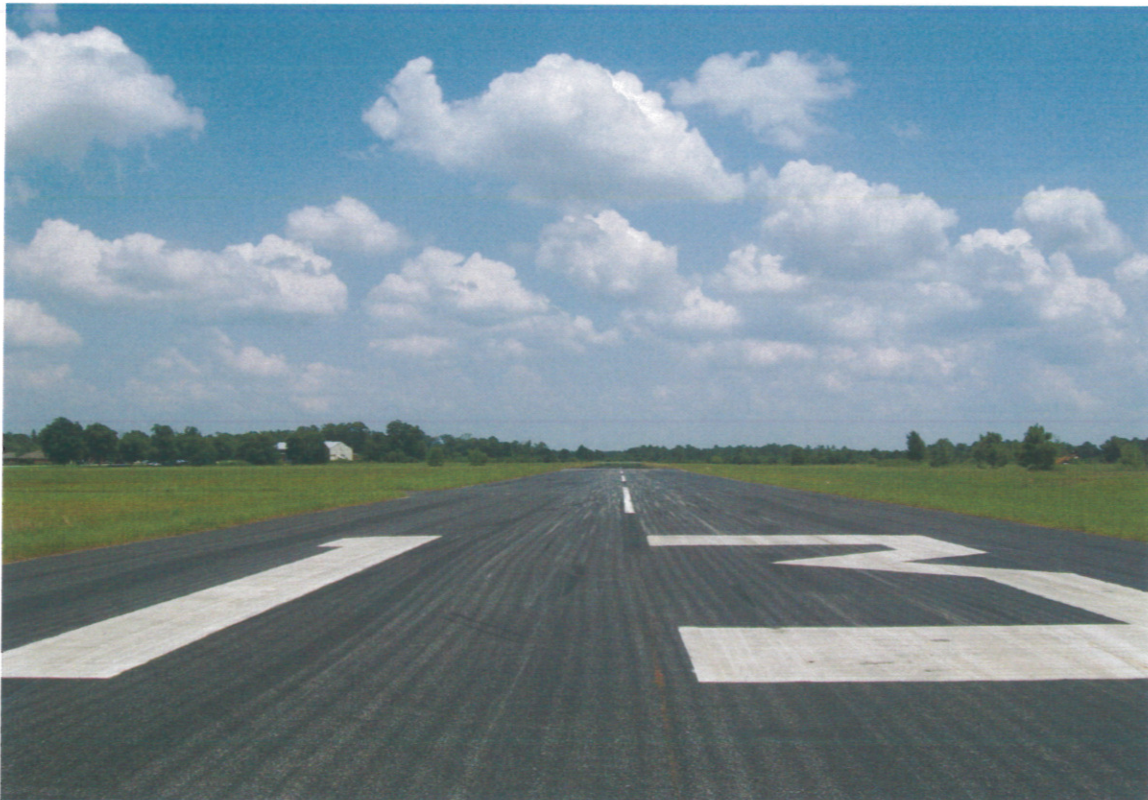
Photo # 5 – Basic Markings Rwy 13

- The airport markings are in good condition (See Photo # 5).

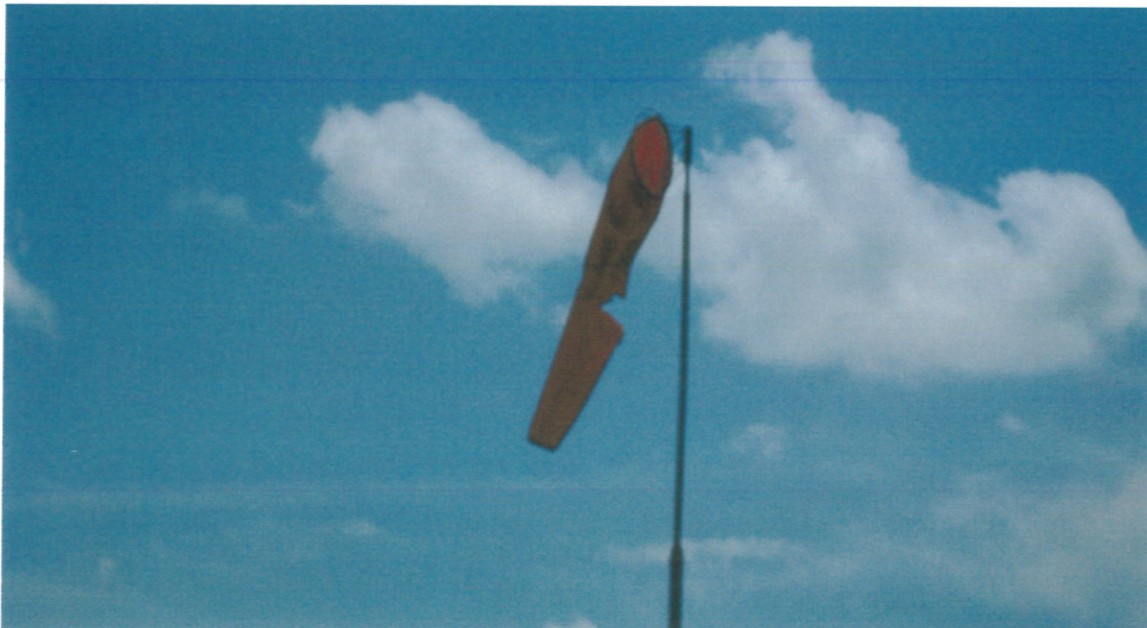
Photo # 6 – Wind Cone

- The wind direction indicator (wind cone) is operational; however the fabric is torn (See Photo # 6).

- Wind cone fabric must be replaced.

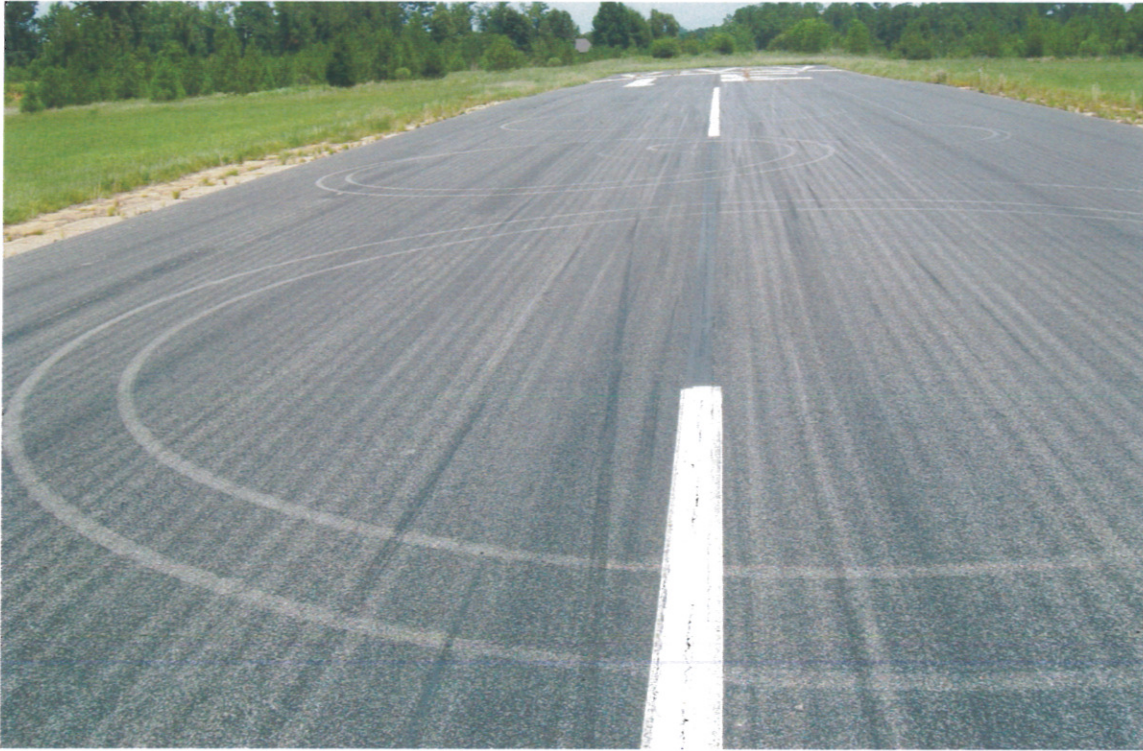
Photo # 7 – Unauthorized Vehicle Traffic

- There is evidence of unauthorized vehicle traffic on runway surfaces (See Photo # 7).

- Unauthorized access might be controlled through signage and routine police and/or sheriff's patrol.

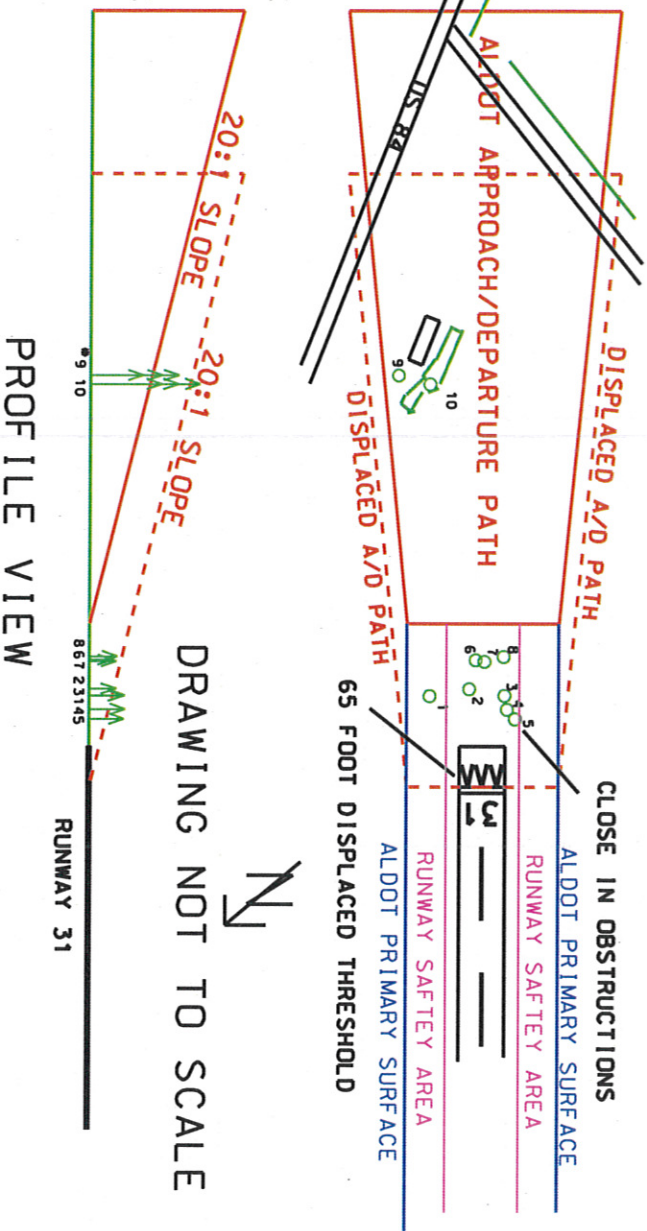
REQUIREMENTS FOR STATE AIRPORT LICESE RUNWAY 31

1. BRUSH - CLOSE IN OBSTRUCTION
 2. BRUSH - CLOSE IN OBSTRUCTION
 3. BRUSH - CLOSE IN OBSTRUCTION
 4. BRUSH - CLOSE IN OBSTRUCTION
 5. BRUSH - CLOSE IN OBSTRUCTION
 6. BRUSH - CLOSE IN OBSTRUCTION
 7. BRUSH - CLOSE IN OBSTRUCTION
 8. BRUSH - CLOSE IN OBSTRUCTION
 9. TREE - 29' ABOVE RUNWAY END
695' FROM DISPLACED THRESHOLD
141' RIGHT OF CENTERLINE
23:1 OBSTRUCTION CLEARANCE SLOPE
 10. TREE - 36' ABOVE RUNWAY END
672' FROM DISPLACED THRESHOLD
89' RIGHT OF CENTERLINE
18:1 OBSTRUCTION CLEARANCE SLOPE
- * NOT AN ALDOT OBSTRUCTION
- NOTE: THIS SKETCH IS PROVIDED FOR
INFORMATIONAL PURPOSES ONLY
AND SHOULD NOT BE USED FOR
ANY OTHER PURPOSE.

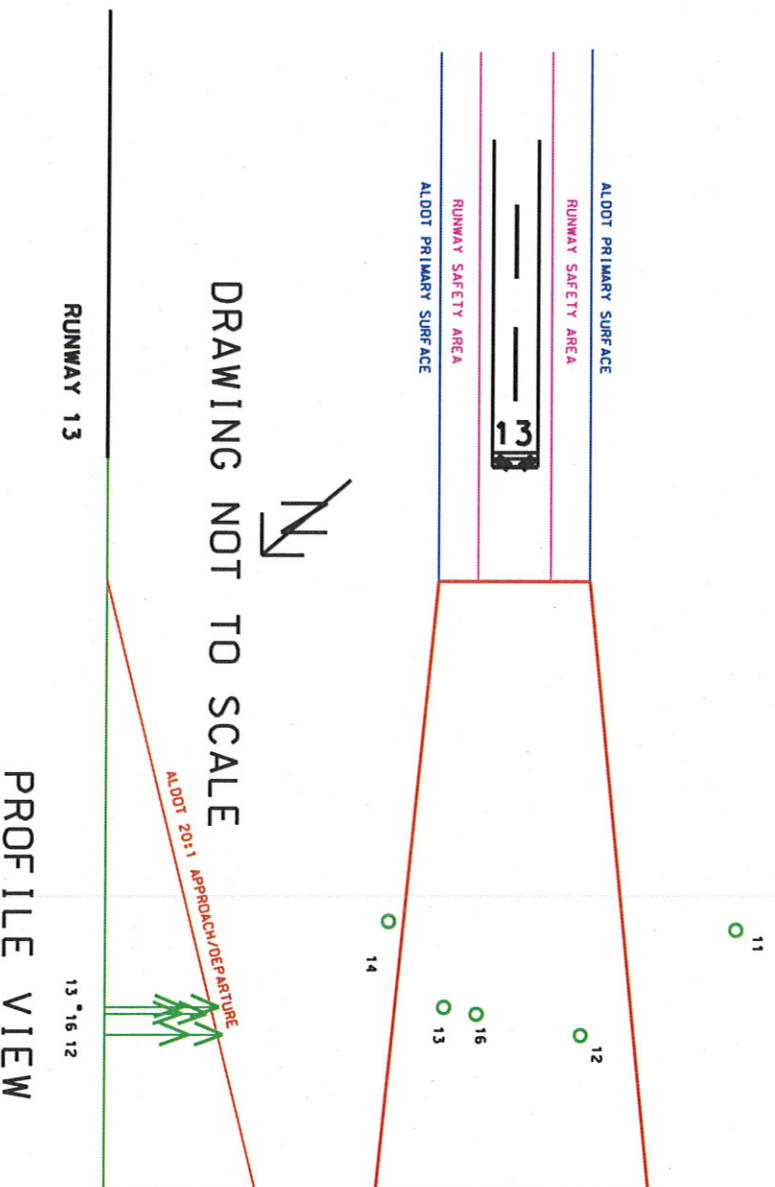
RUNWAY 13

- 12. TREE - 39' ABOVE RUNWAY END
966' FROM RUNWAY END
112' RIGHT OF CENTERLINE
19:1 OBSTRUCTION CLEARANCE SLOPE
- 13. TREE - 38' ABOVE RUNWAY END
903' FROM RUNWAY END
114' RIGHT OF CENTERLINE
8:1 OBSTRUCTION CLEARANCE SLOPE
- 16. TREE - 33.6' ABOVE RUNWAY END
909' FROM RUNWAY END
60' RIGHT OF CENTERLINE
21:1 OBSTRUCTION CLEARANCE SLOPE
